**AIRCRAFT ACCIDENT REPORT**

**SOUTHERN AIRWAYS, INC. DC-9, N97S**

**Tri-State Airport**

**REPORT NUMBER: NTSB-AAR-72-11**

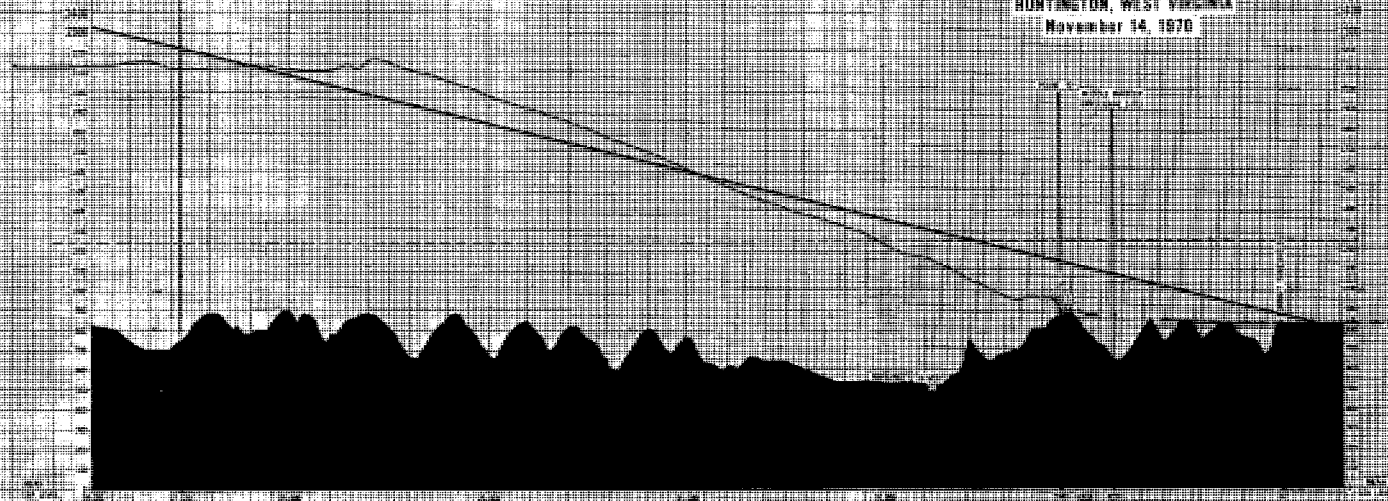
Glide Path Intercepts runway 940 feet beyond  
 runway threshold.  
 Vertical Scale distorted by ratio of 3:1.
