# Son Care Foundation – Lean to Shade Structure Design and Construction

This paper discusses the design and construction of a lean-to-shade structure built for the Son Care Foundation in San Luis Obispo. The Son Care Foundation is a nonprofit organization that raises guide dogs for veterans and first responders with PTSD. This shade structure is 16 feet long and 6 feet wide, its height slopes from 9 feet in the front down to 8 feet in the back creating a roof pitch of 2:12. The sheet metal roof also has an overhang of approximately 1 foot. As requested by the client, the shade structure was designed to fit the aesthetic of the existing shade structures in the area. After developing a design, with the assistance of architectural engineering students, structural calculations confirmed that the structure was designed adequately for all potential loading conditions. Due to the interdisciplinary collaboration required for the design and construction of this project, the Alliance provided funding for the project through their Hasslein Fund, which provides funding for projects that foster collaboration between different majors. The construction processes included in this project were sit

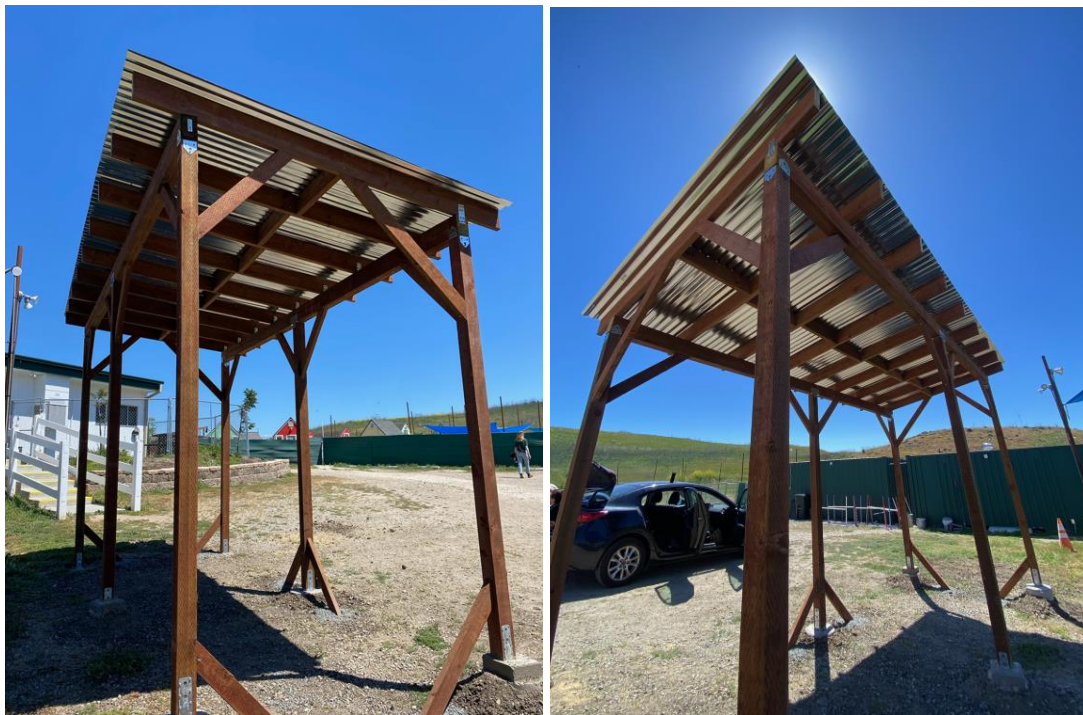
Figure 1&2. Completed Lean to Shade Structure

Overall, this project was a huge success. The strength of the structure is outstanding and is tied to the ground with 6 reinforced 2ft deep piers that sit below the frost line and an additional 6 concrete embedded cross braces that provide moment force resistance in a type of structure that is notorious for lack of moment support and warping. Once the framing was all tied together with the 4"x6" beams,

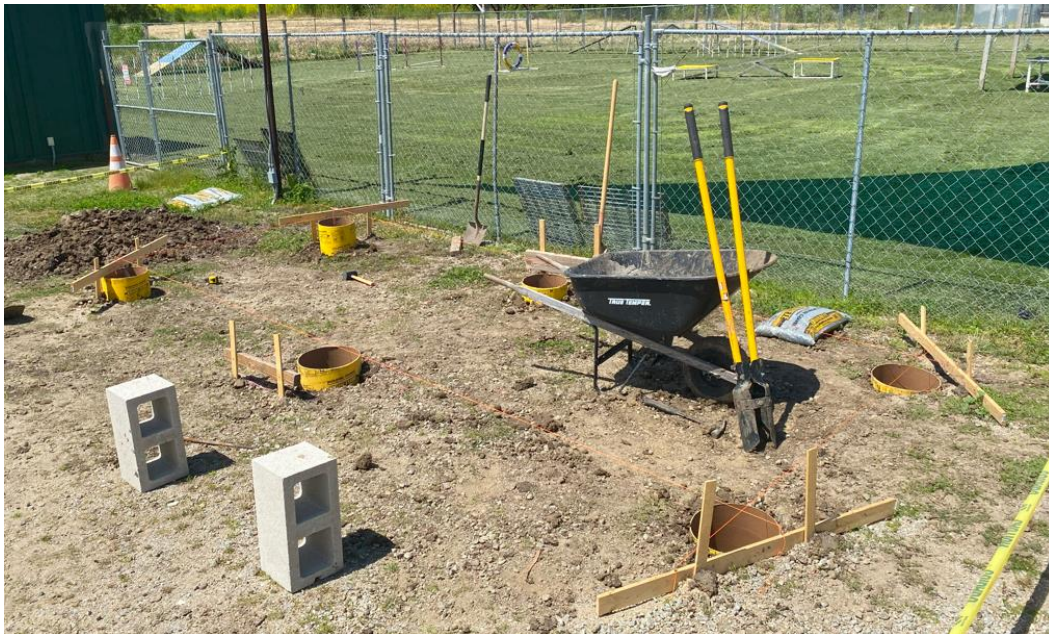
Figure 4. Formwork Set

The foundation for this shade structure consists of 6 12" diameter, 2ft deep footing piers. Each hole was dug to approximately 2ft deep but adjustments were made to account for the change in elevation from each hole to make sure the tops of each pier were level. Once each hole was dug, 12" Quickcrete cardboard concrete form tubes were set and leveled with dirt backfilled around them. At the bottom of each hole a 1inch thick layer of gravel was added to assist with drainage and to prevent concrete from being in direct contact with potential groundwater. Once form work and gravel were set Quickcrete concrete bags were mixed using a concrete mixer provided by the Son Care Foundation and poured into formwork. Two pieces of #4 rebar approximately 1ft long were added to each pier. Embedded in the piers were Simpson Strong Tie PBS ZMAX Post bases with an added 1/2"x6" anchor bolt for extra uplift strength. These post bases form the connection between the concrete piers and 4"x4" posts. Concrete was then left to cure for 7 days per the manufactures recommendation.

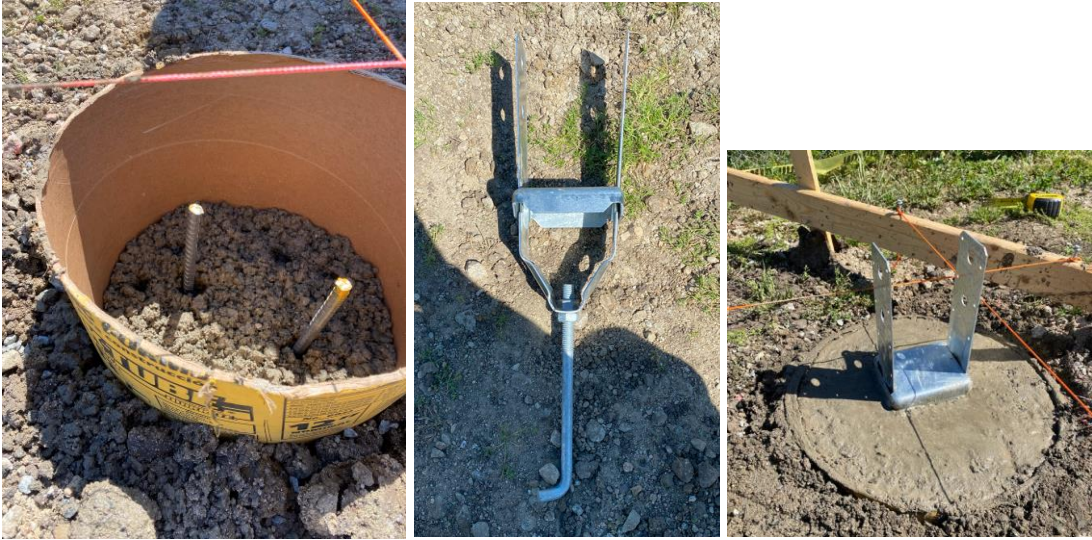
Figure 5-7. Foundation Hardware

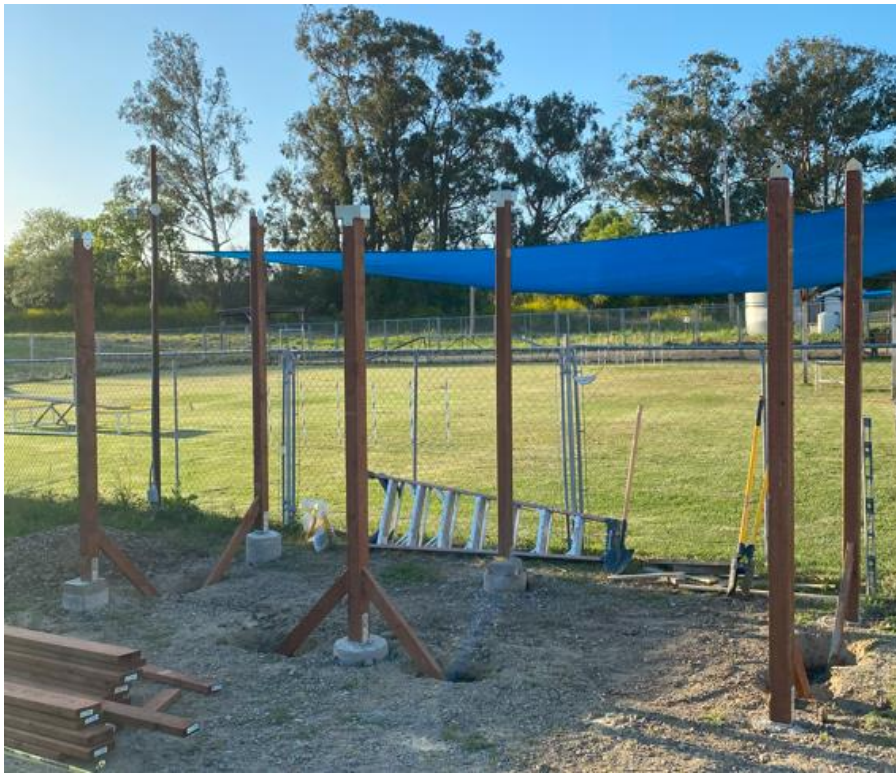
Figure 8. 4"x4" Posts and Embedded Cross Braces Set

To provide extra foundation support, cross braces were added to the base of 5 of the posts and embedded in concrete 1ft deep, these were added for a couple of reasons. First was to support the moment of forces in the direction that the post bases provided no support for. These post bases only supported the 4"x4" columns in one direction, so without the cross braces, due to the moment force around the post base the structure would overtime begin to lean forward and eventually fall. Since the Son Care Foundation plans to move the existing fence to enclose the shade structure, these cross braces will not impede the function/use of the structure at all. Upon inspecting similar shade structures on site, many leaning forward and not having cross braces, our team could tell that these cross braces would be crucial to the longevity of our shade structure. Once secured and concrete had cured these embedded cross braces added great strength and stability to the structure.

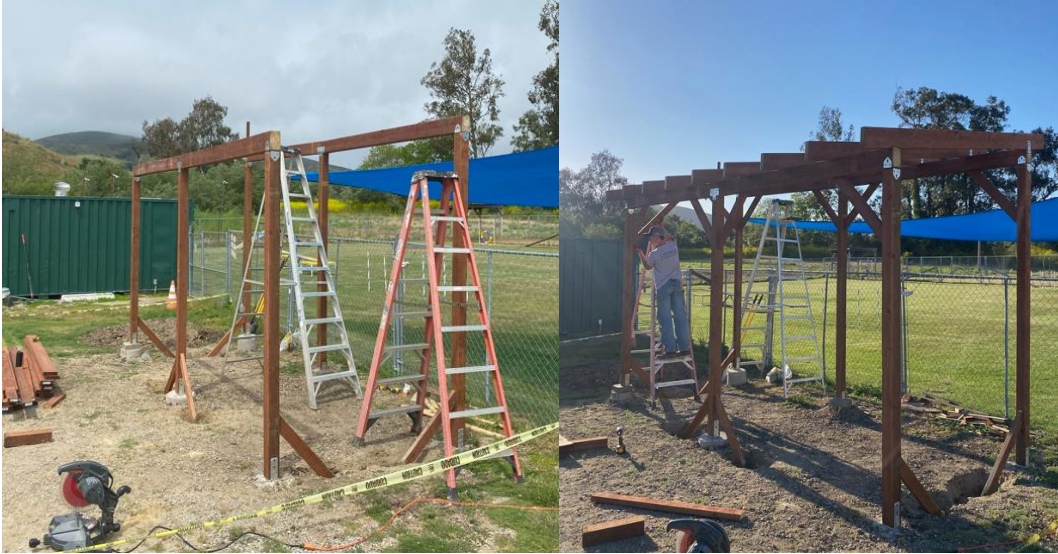
Figure 8&9. 4"x6" Beam and Rafter Framing

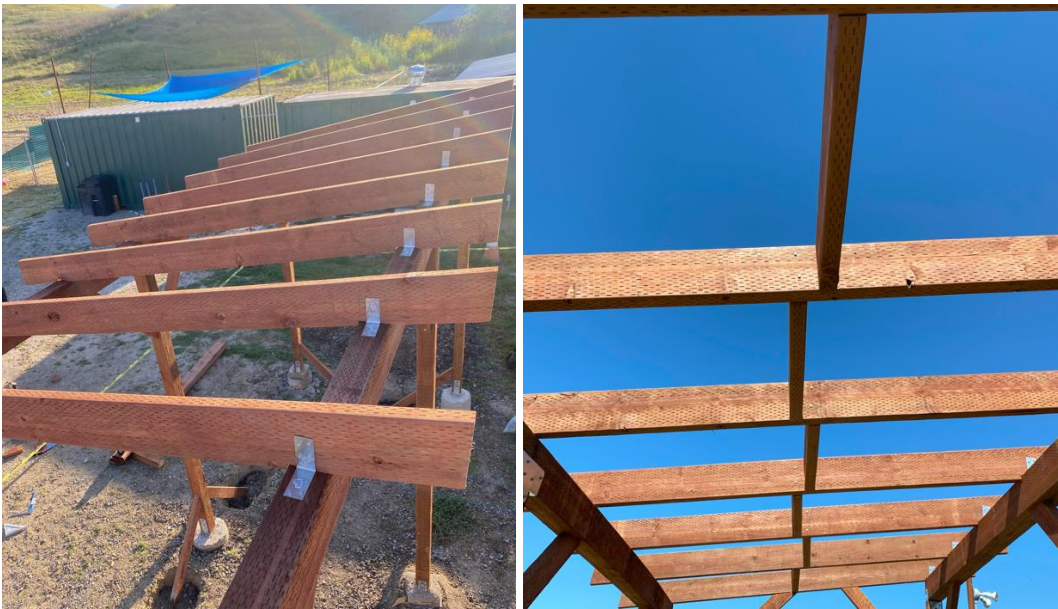
Figure 10&11. 2"x6" Rafters (Left) and Blocking (Right)
